**LPC# 031 186 0037 - Cook County
Marvel Engineering - Melrose Park
ILD 984 837 104
SF/HRS**

Site Reassessment

Title: CERCLA Site Inspection for Marvel Engineering

**MARVEL ENGINEERING
ILD 984 837 104
LPC 031 186 0037
MELROSE PARK, ILLINOIS**

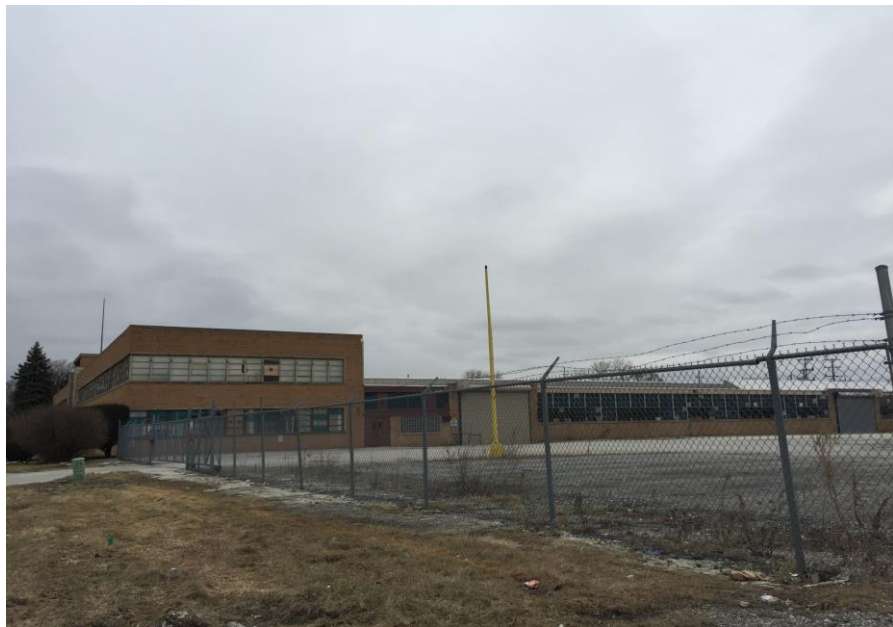
| COMMENTS: Photo taken of the former Marvel Engineering building from the south side. Property was fenced on this side. | |

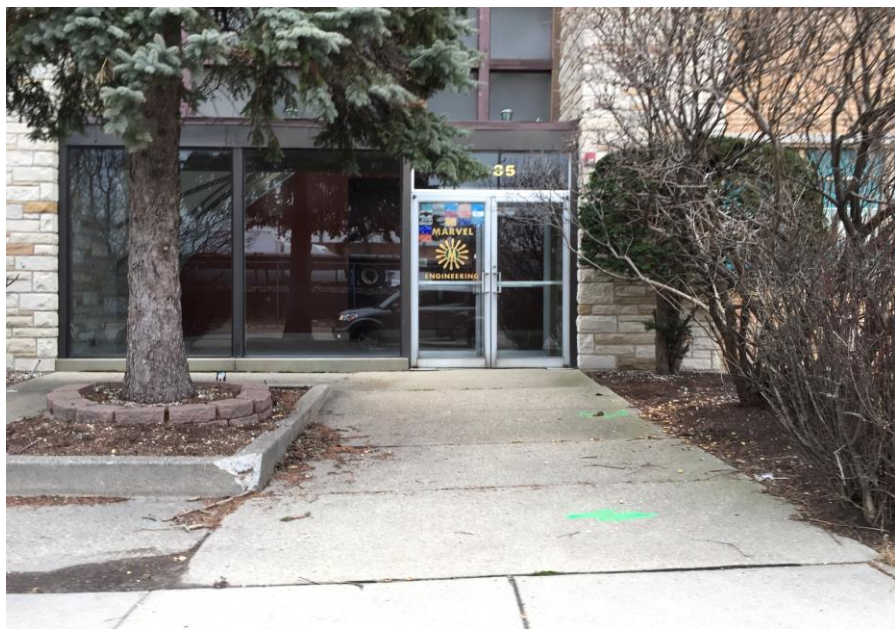
| COMMENTS: Photo taken of the door located on the west side of the building. Door was locked as Marvel has moved to a new location. | |

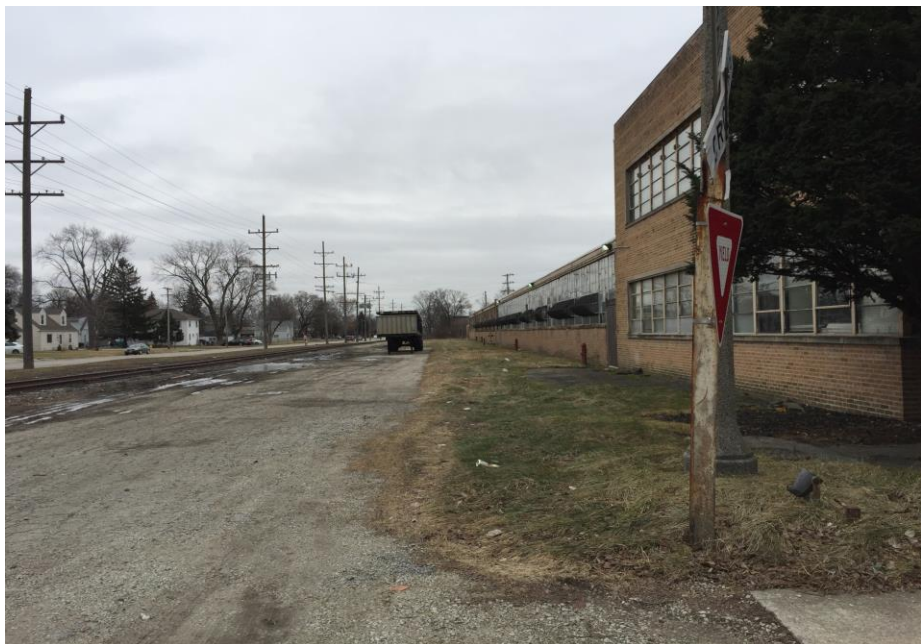
| COMMENTS: Photo taken of the north side of the building. This side was also fenced further to the east. | |

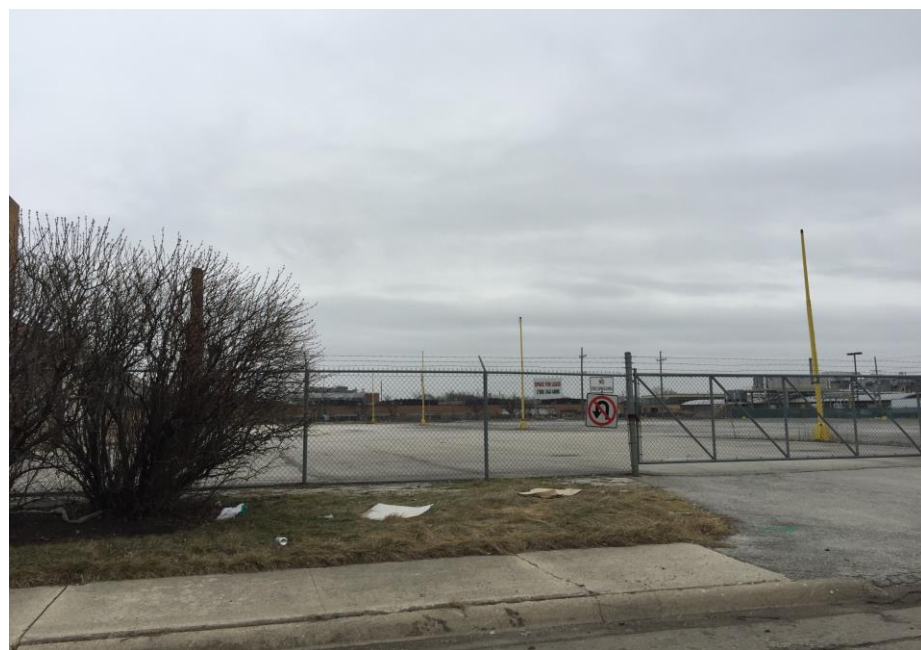
| COMMENTS: Photo take from Hawthorne avenue looking east on the south side of the building. No trespassing sign is posted as well as space for lease. 708-343-4031 | |
